NTSB Investigative Process Office of Highway Safety

Multivehicle Crash Mt. Pleasant Township, Pennsylvania

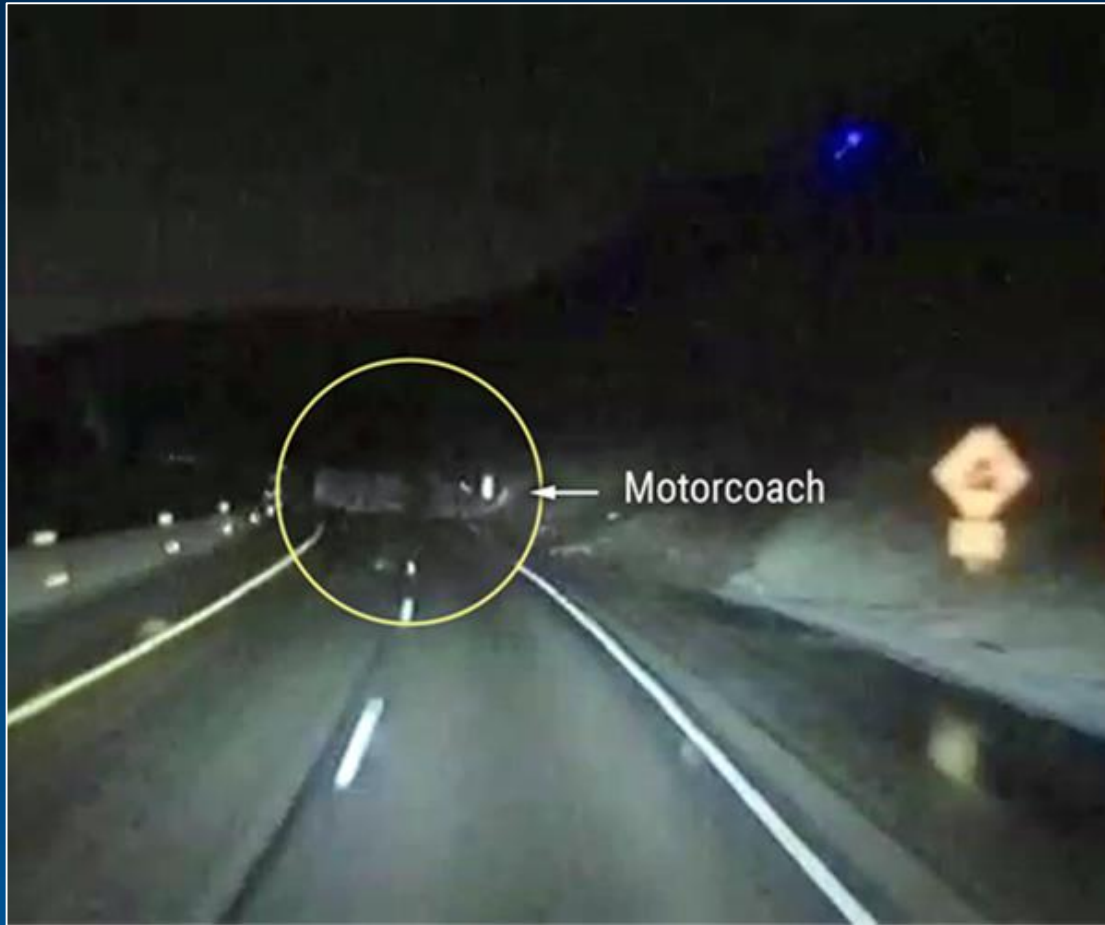
Overtaken Motorcoach

- Initial position of rest was blocking both travel lanes and shoulders
- Entered curve at 77 mph
- Light braking upon entering curve decreased speed to 70 mph
- After brakes released vehicle speed changes not associated with braking or throttle occurred
- Speed changes consistent with vehicle yawing from excessive steering inputs
- Sufficient roadway traction existed for normal travel

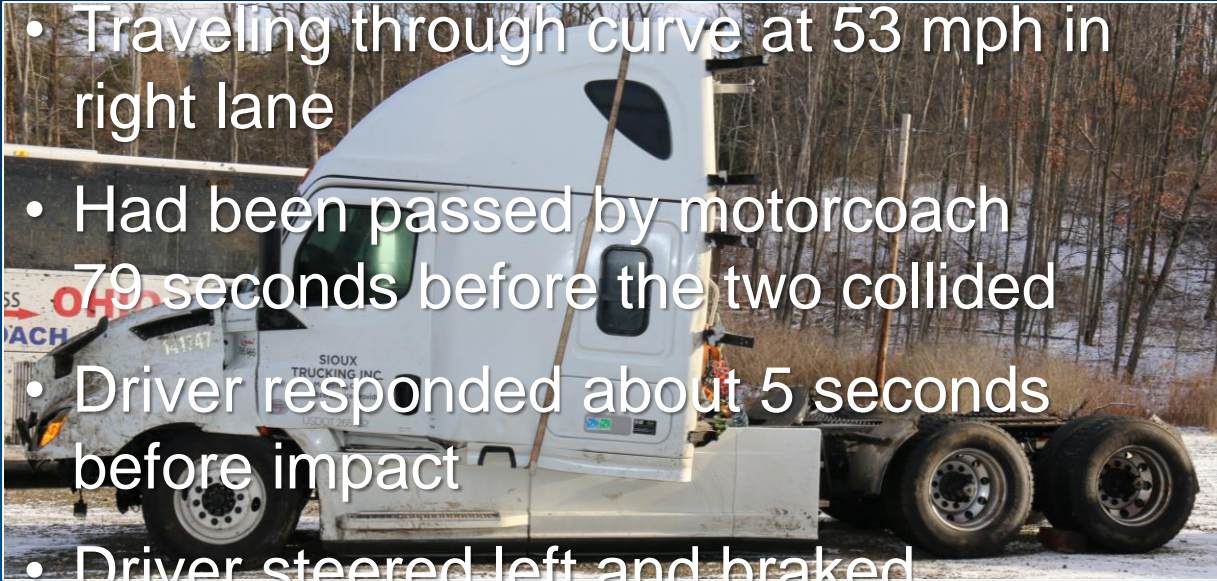
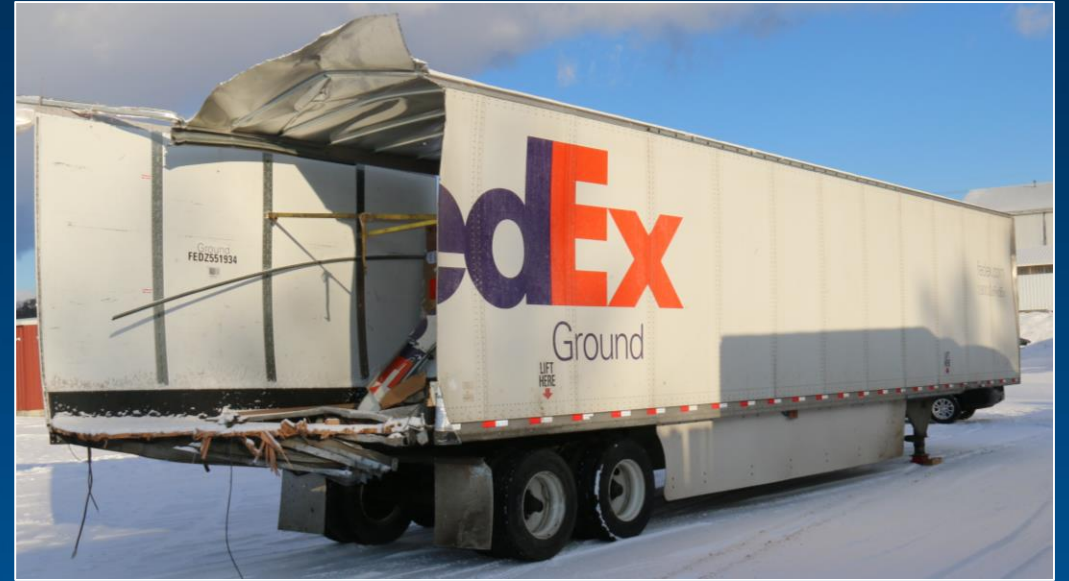
FedEx Combination Unit

- Traveling through curve at 53 mph in right lane
- Had been passed by motorcoach 79 seconds before the two collided
- Driver responded about 5 seconds before impact
- Driver steered left and braked, impacted motorcoach at about 21 mph

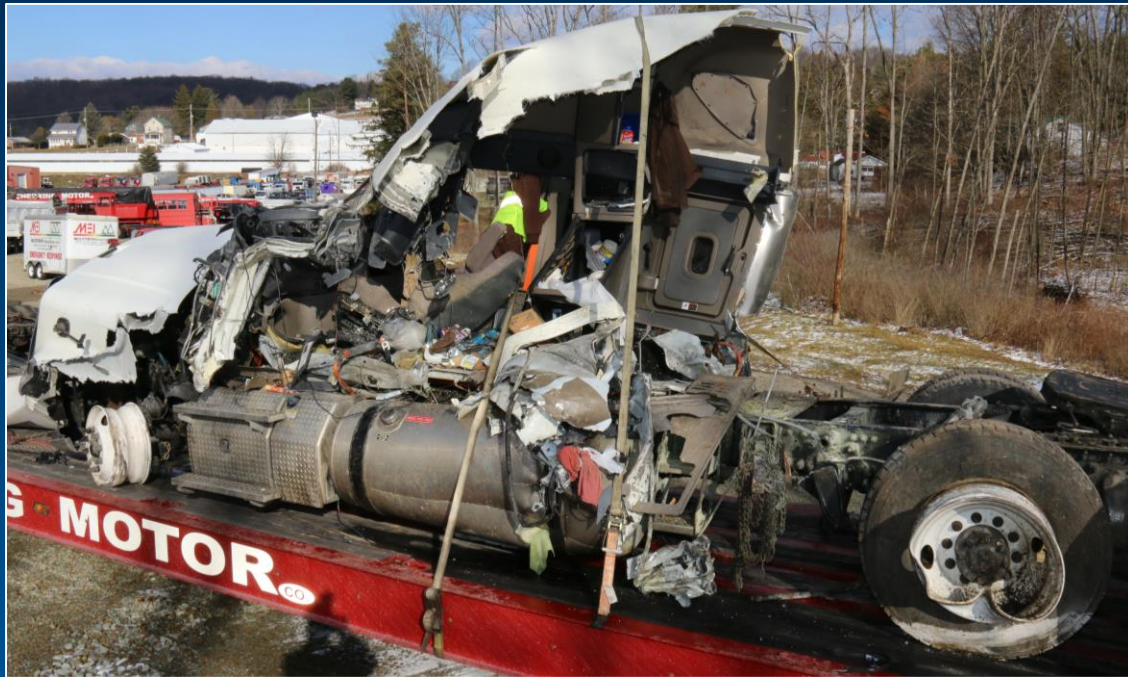
UPS-1 Combination Unit

- Entered curve at 71 mph, traveling in left lane
- Evidence that driver braked and swerved to the right
- Tractor collided with right rear of FedEx trailer
- Average speed 67 mph during preceding two hours of travel on turnpike

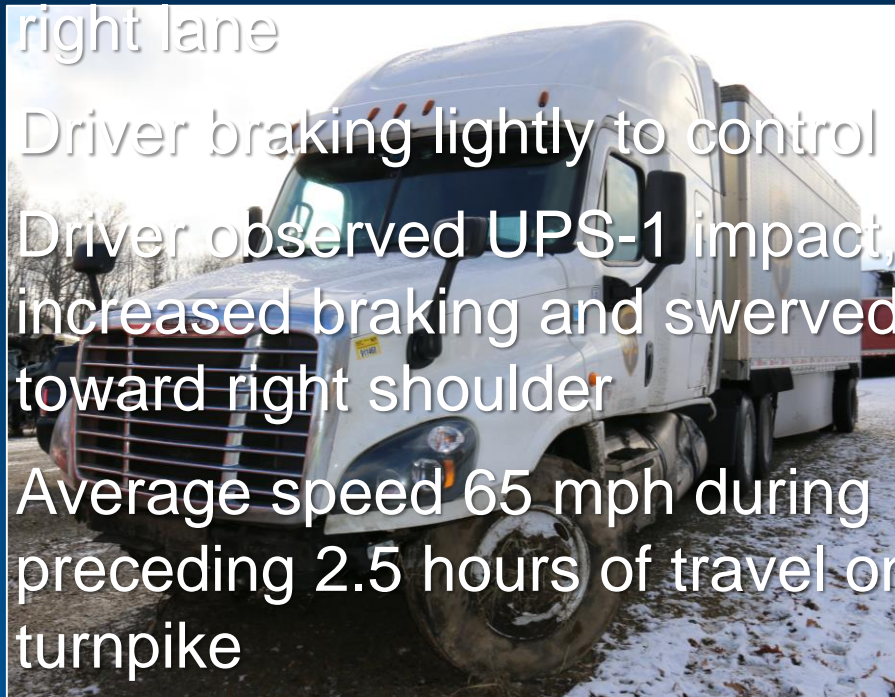
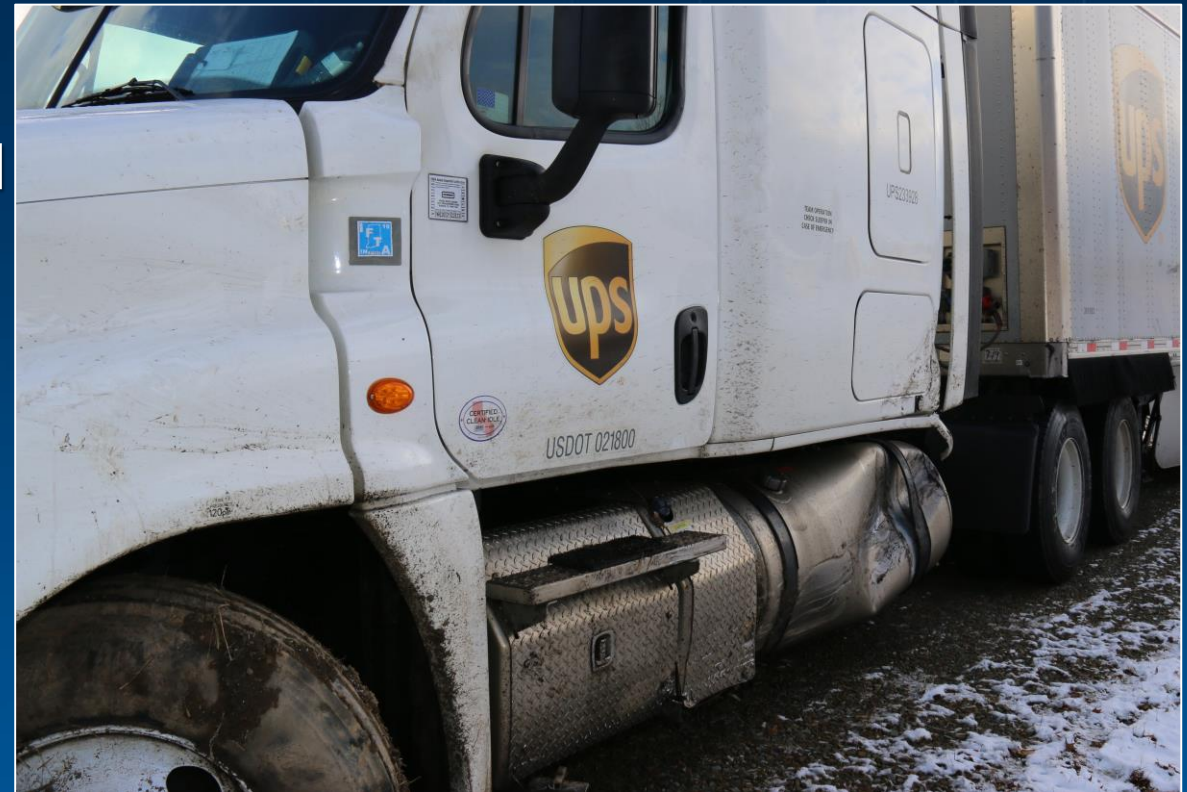
UPS-2 Combination Unit

- Entered curve at 69 mph, traveling in right lane
- Driver braking lightly to control speed
- Driver observed UPS-1 impact, increased braking and swerved toward right shoulder
- Average speed 65 mph during preceding 2.5 hours of travel on turnpike

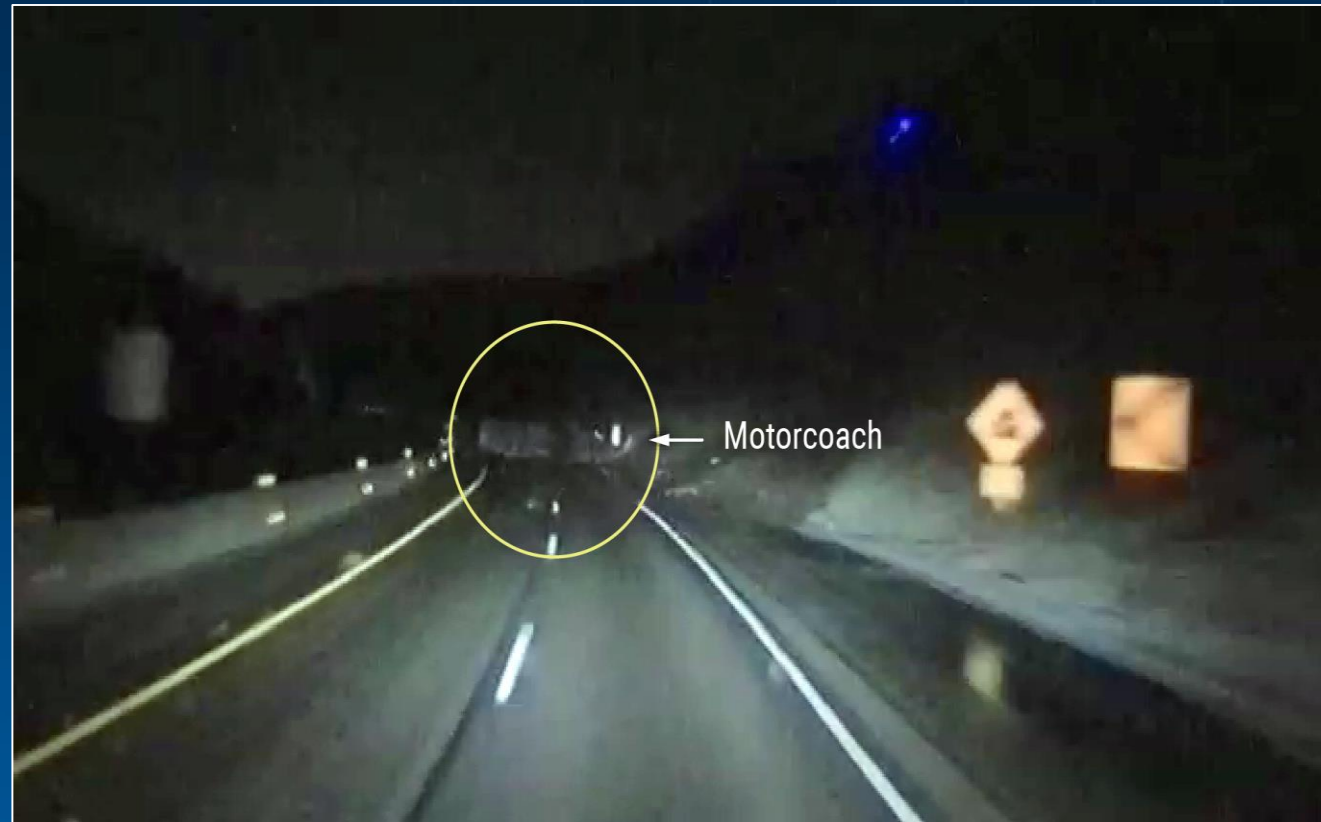
FedEx Driver Response

- FedEx truck entered curve at 53 mph
- Driver steered to left, applied brake
- Driver reacted within 0.3 seconds
- FedEx truck slowed to 21 mph

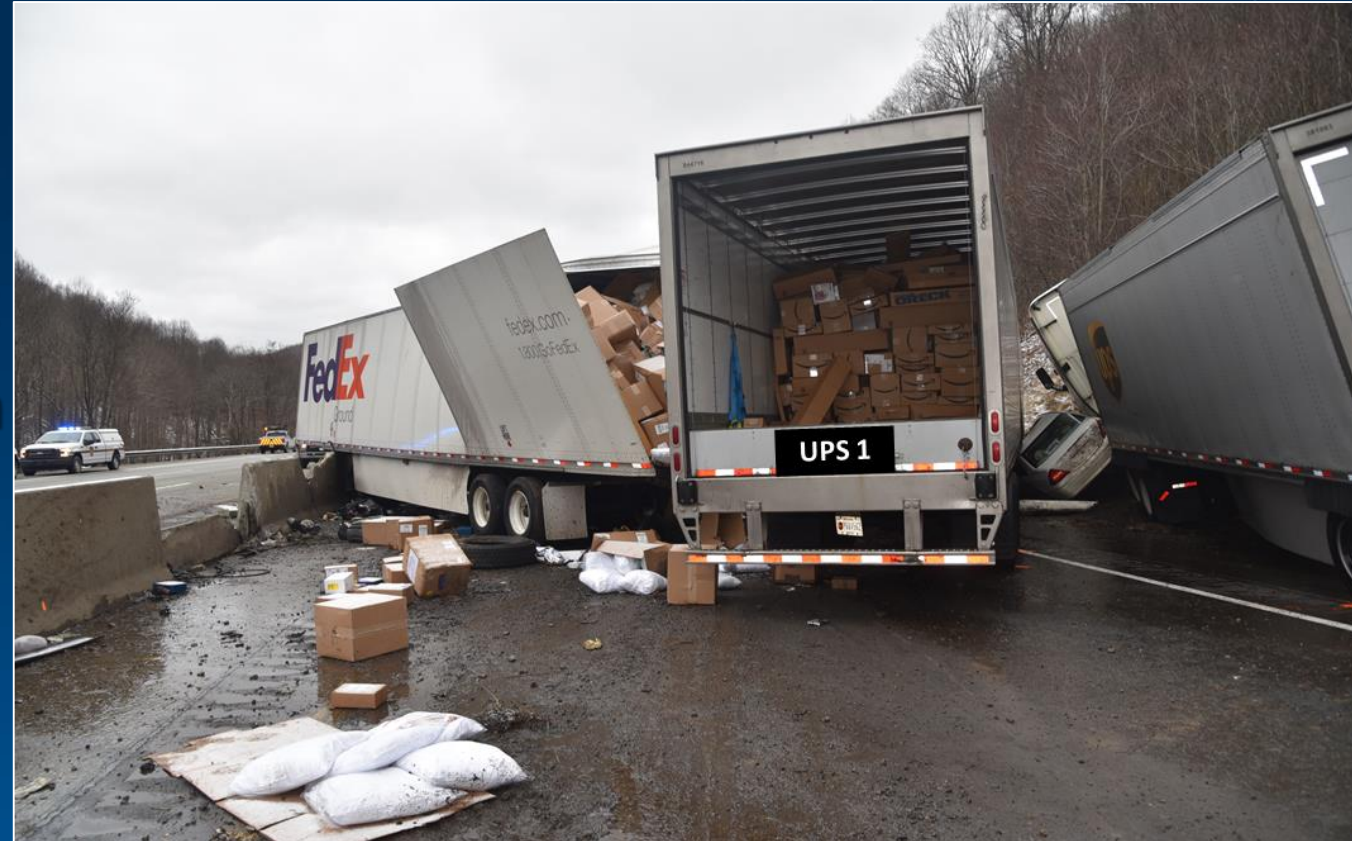
UPS-1 Driver Response

- UPS-1 entered curve at 71 mph
- FedEx truck had begun slowing
- Driver applied brakes, steered right
- UPS-1 collision occurred at 56 mph

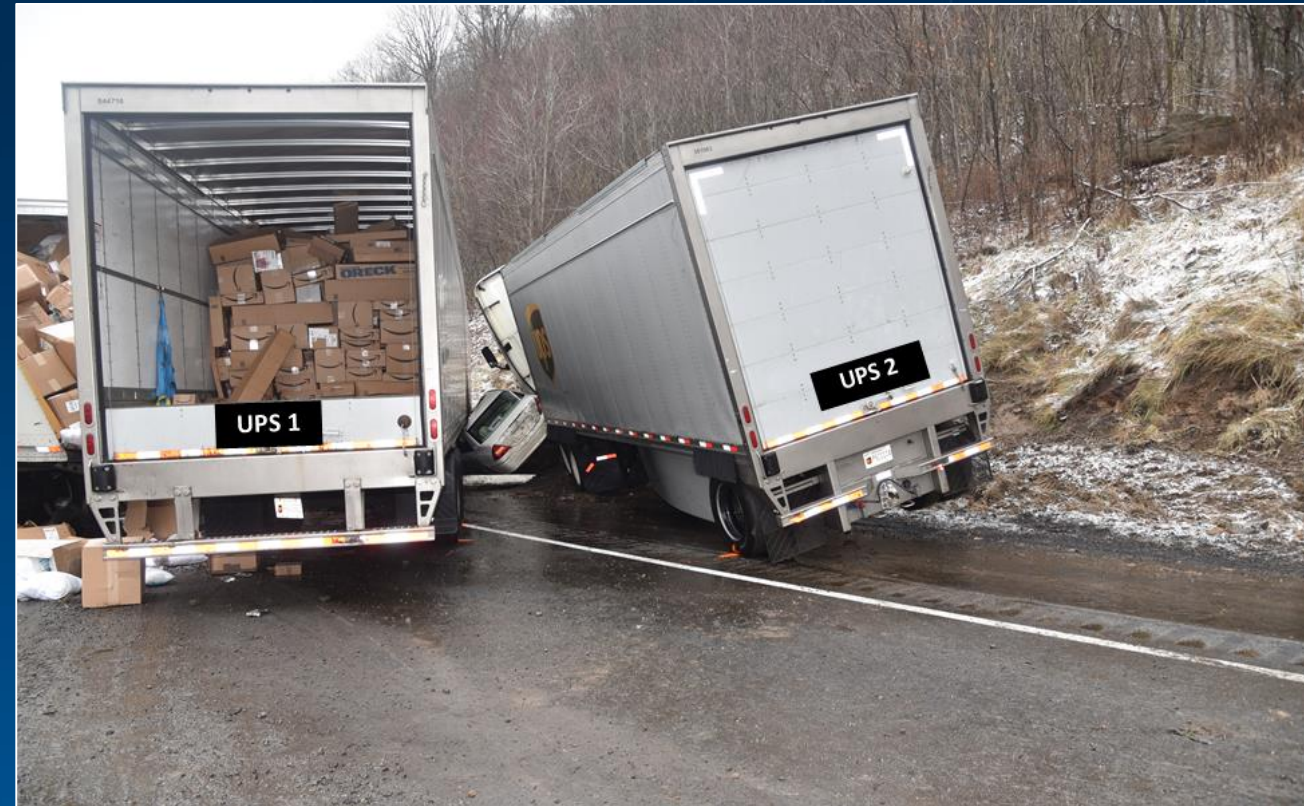
UPS-2 Driver Response

- UPS-2 entered curve at 69 mph
- UPS-2 3–5 seconds behind UPS-1
- Driver observed UPS-1 collision
- Driver applied brakes, steered right
- UPS-2 came to rest next to sedan

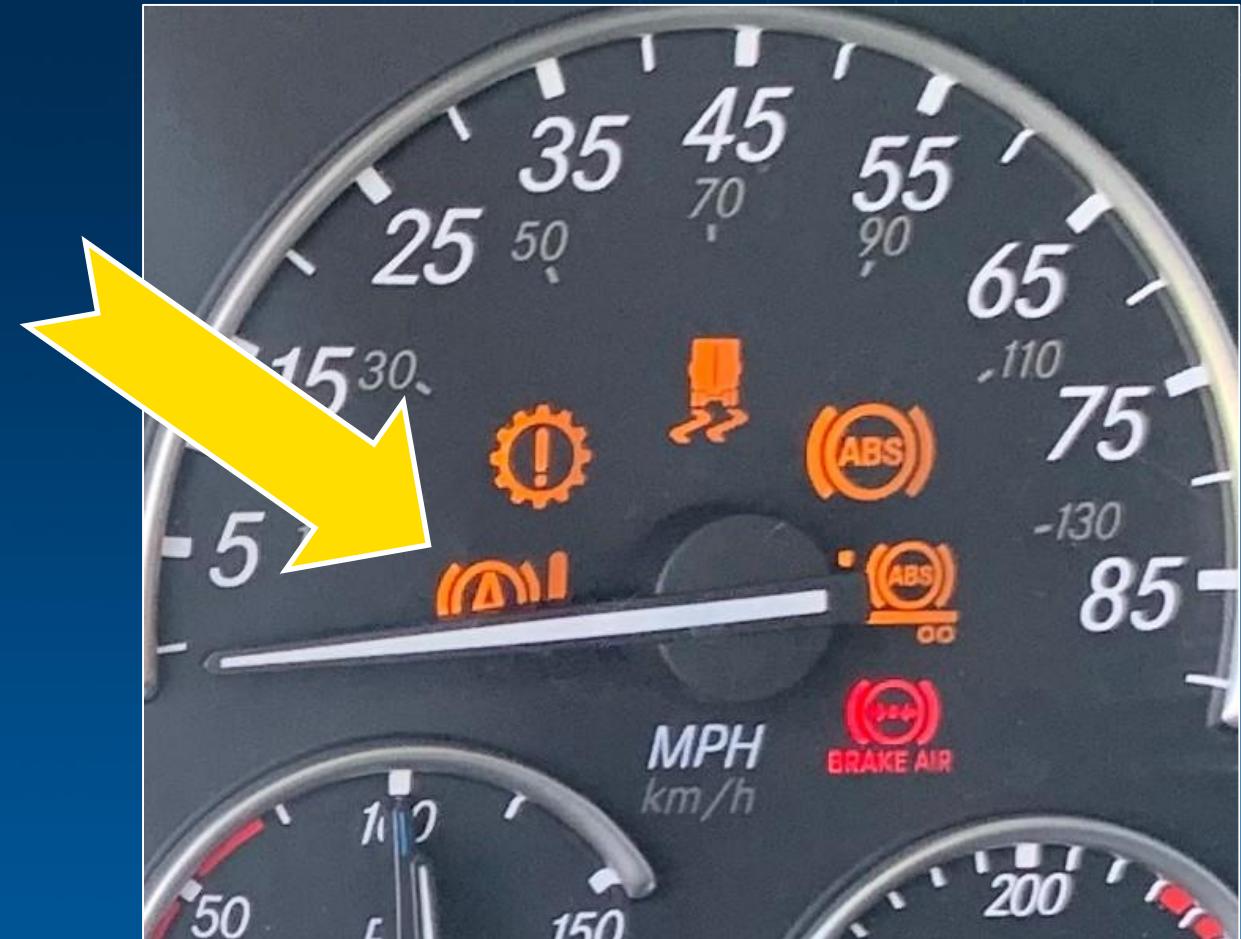
Driver Vehicle Inspection Reports from UPS Truck 1

- UPS Truck 1 – misaligned radar sensor
- Error code and warning since June 2019
 - Detected by Penske in July 2019
 - Noted several times on maintenance records
 - No Driver Vehicle Inspection Report (DVIR) entry by driver

- Penske
 - Places vehicle with Forward Collision Avoidance System defects out of service
 - Lessor receives notification email
 - Between May 2020 and December 2021, over 6,300 vehicles affected
- UPS
 - Changed driver training
 - Changed check ride form to account for advanced safety systems
