NTSB Investigative Process Office of Highway Safety

Multivehicle Crash Mt. Pleasant Township, Pennsylvania

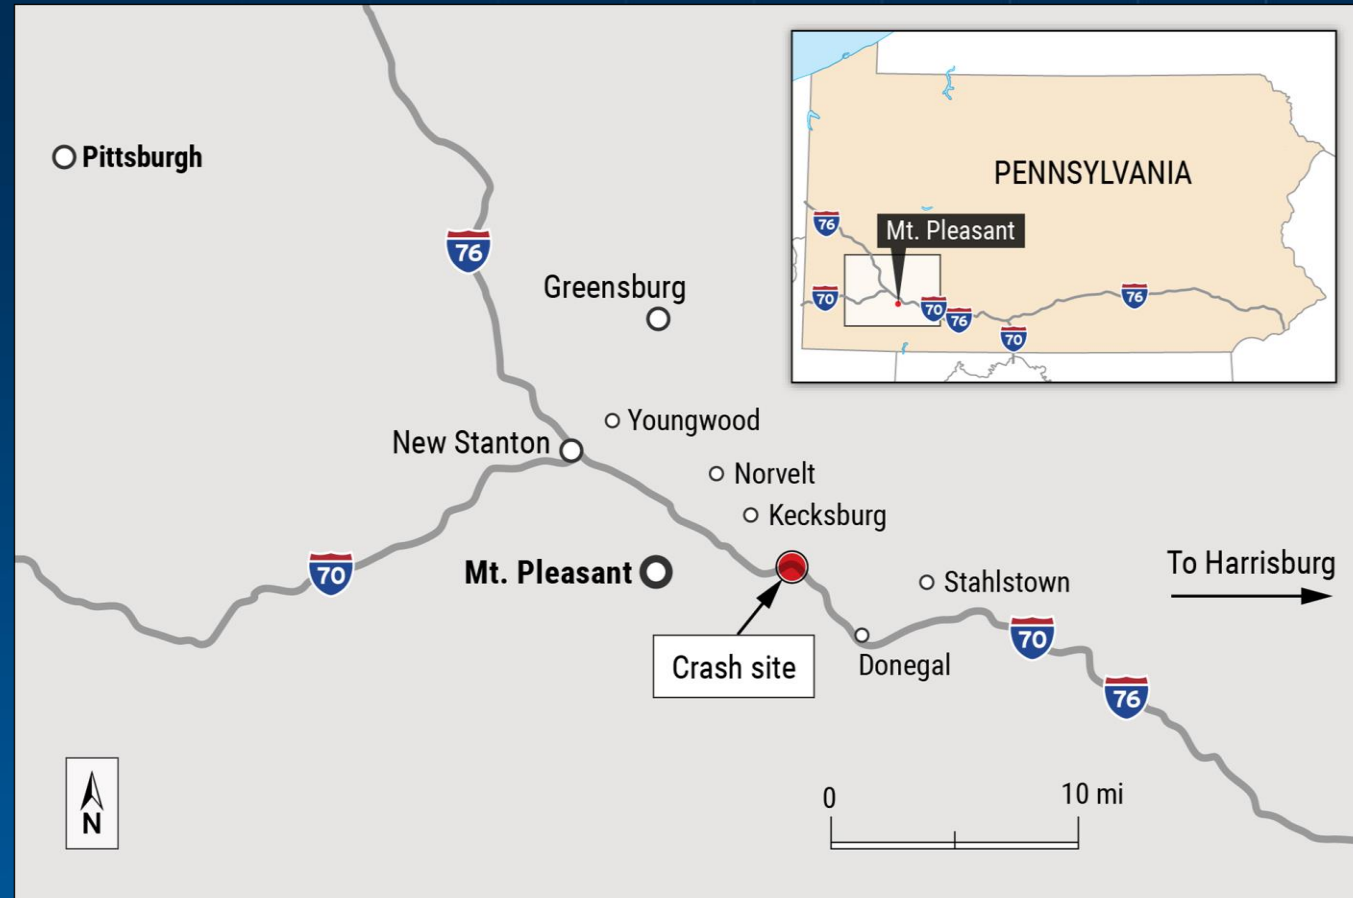
Crash Information and Location

- Interstate 70/76
 - Pennsylvania Turnpike
 - Curving mountainous section
 - 36 miles southeast of Pittsburgh
 - Mt. Pleasant Township

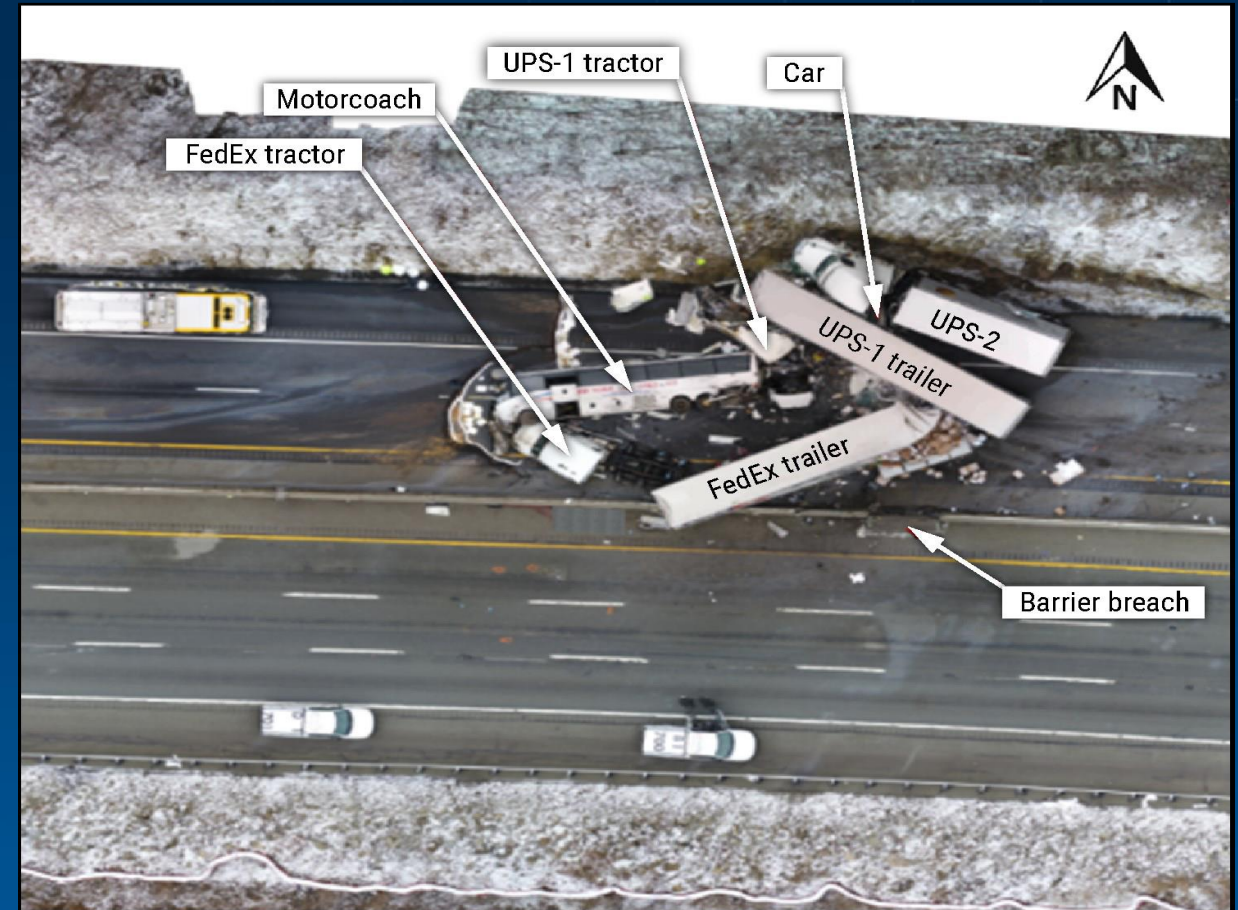
Crash Vehicles

- Final rest positions of vehicles
 - Motorcoach
 - FedEx tractor & trailer
 - UPS-1 tractor & trailer
 - Passenger car
 - UPS-2 tractor & trailer

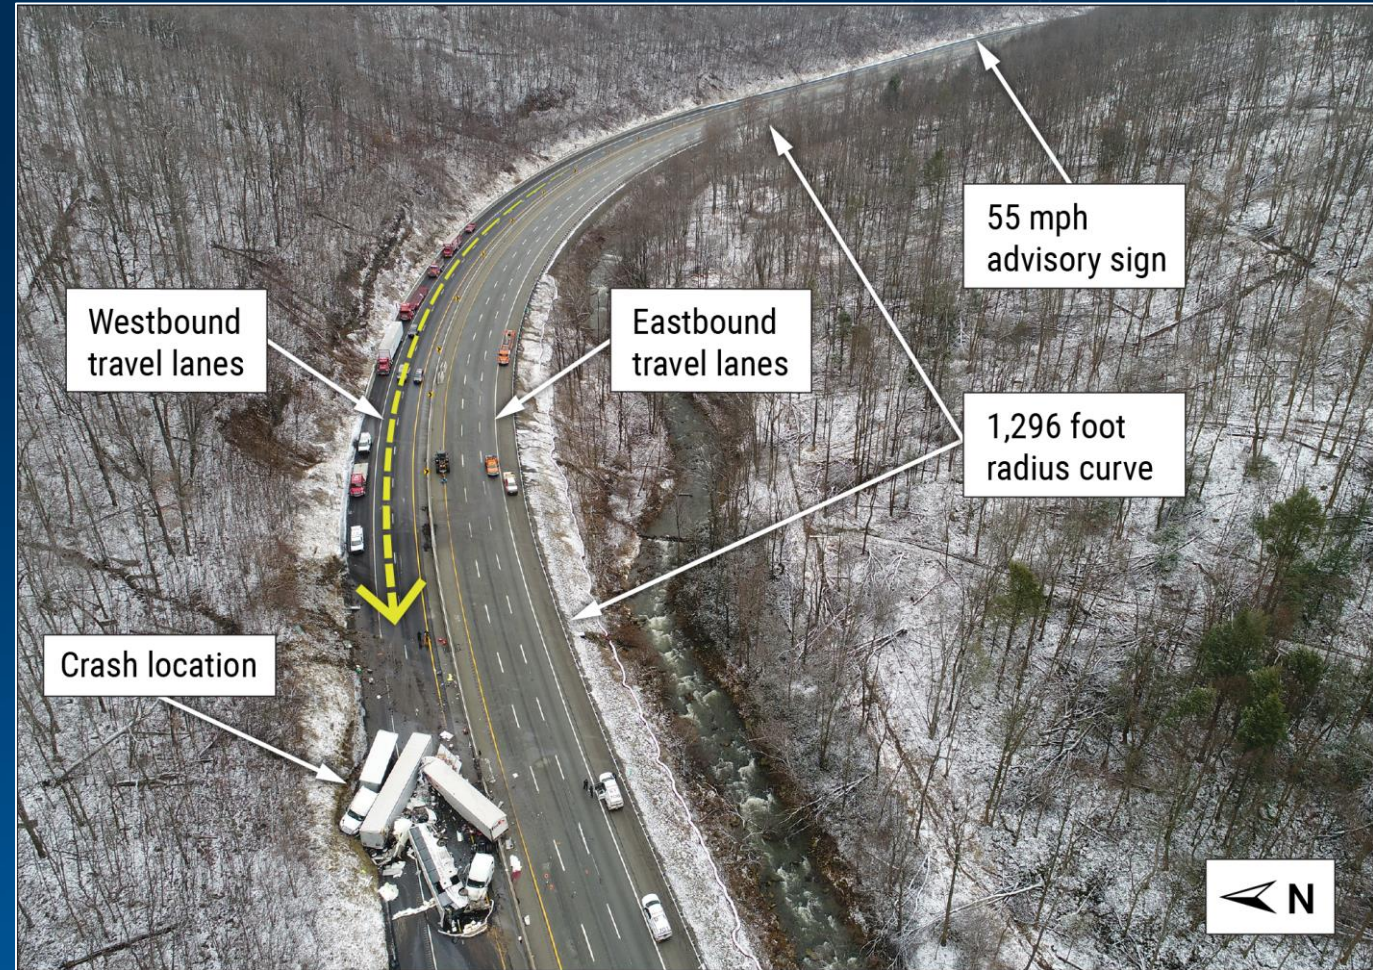
Crash Scene

- Vehicles at final rest
- Left-hand curve
- East and westbound lanes
- 55-mph warning sign

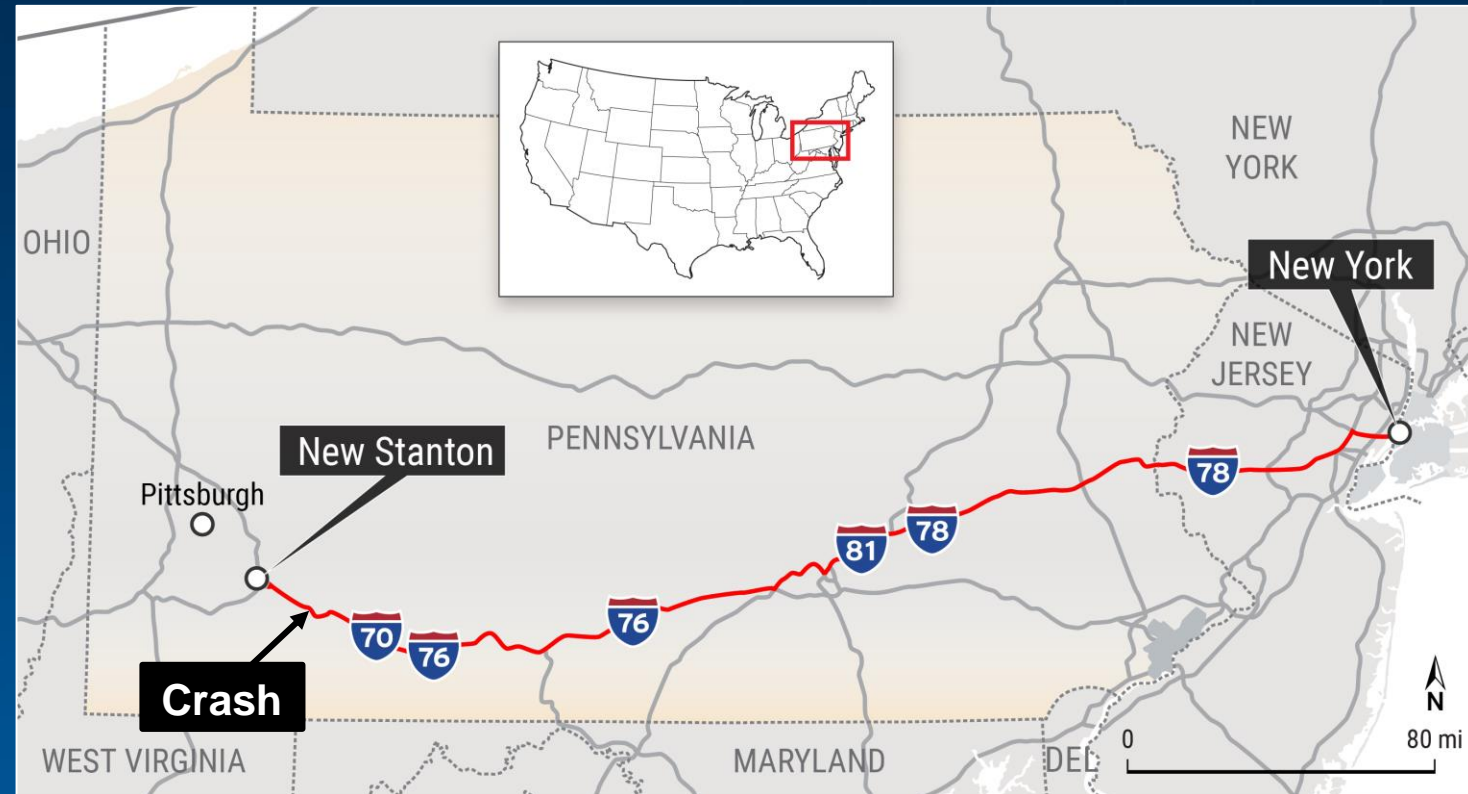
Motorcoach Crash Trip

- Departed NYC at 10:00 p.m.
- Scheduled arrival 4:15 a.m.
- 10 miles from destination
- Driving for 7 hours
- Unable to determine sleep

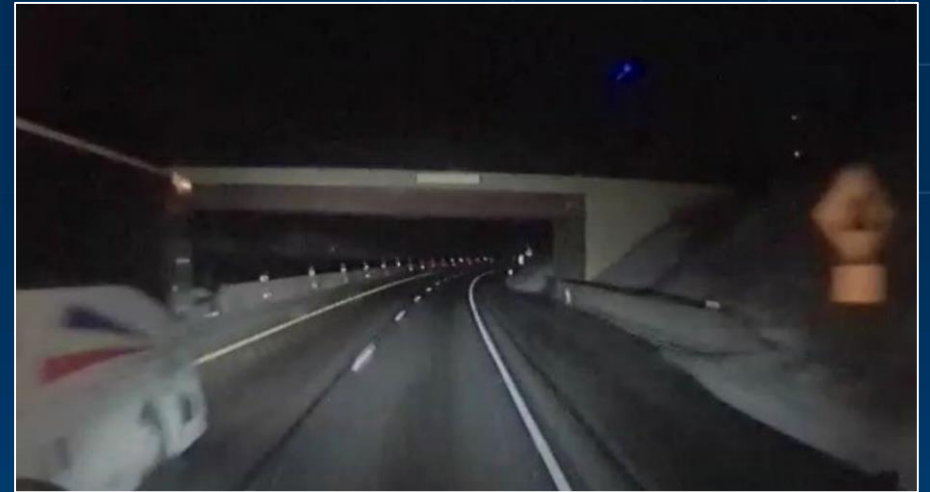
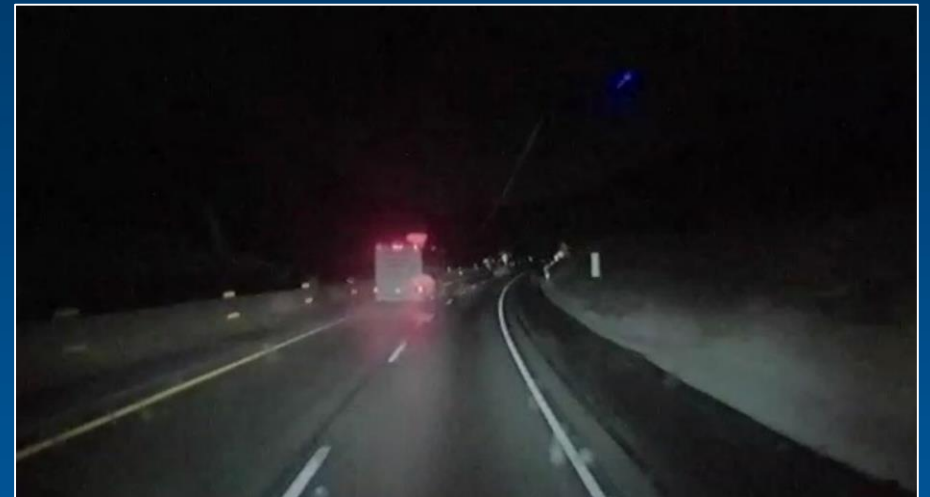
Onboard Video Event Recorders

- FedEx truck video system provided key information:
 - Motorcoach speed and lane position when passing
 - Position and visibility of overturned motorcoach on roadway
 - FedEx driver reacted quickly to hazard
 - FedEx truck speed and crash severity

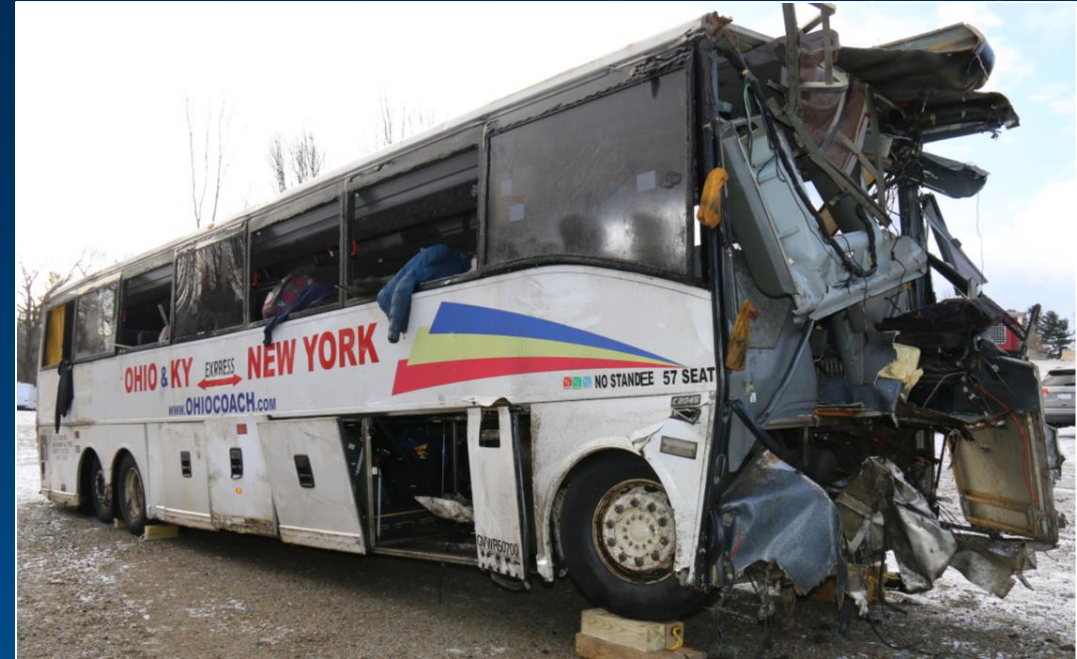
Lack of Data on Motorcoach

- Cause of motorcoach initial loss of control
- Driver performance including steering inputs and fatigue
- Engagement of engine brake

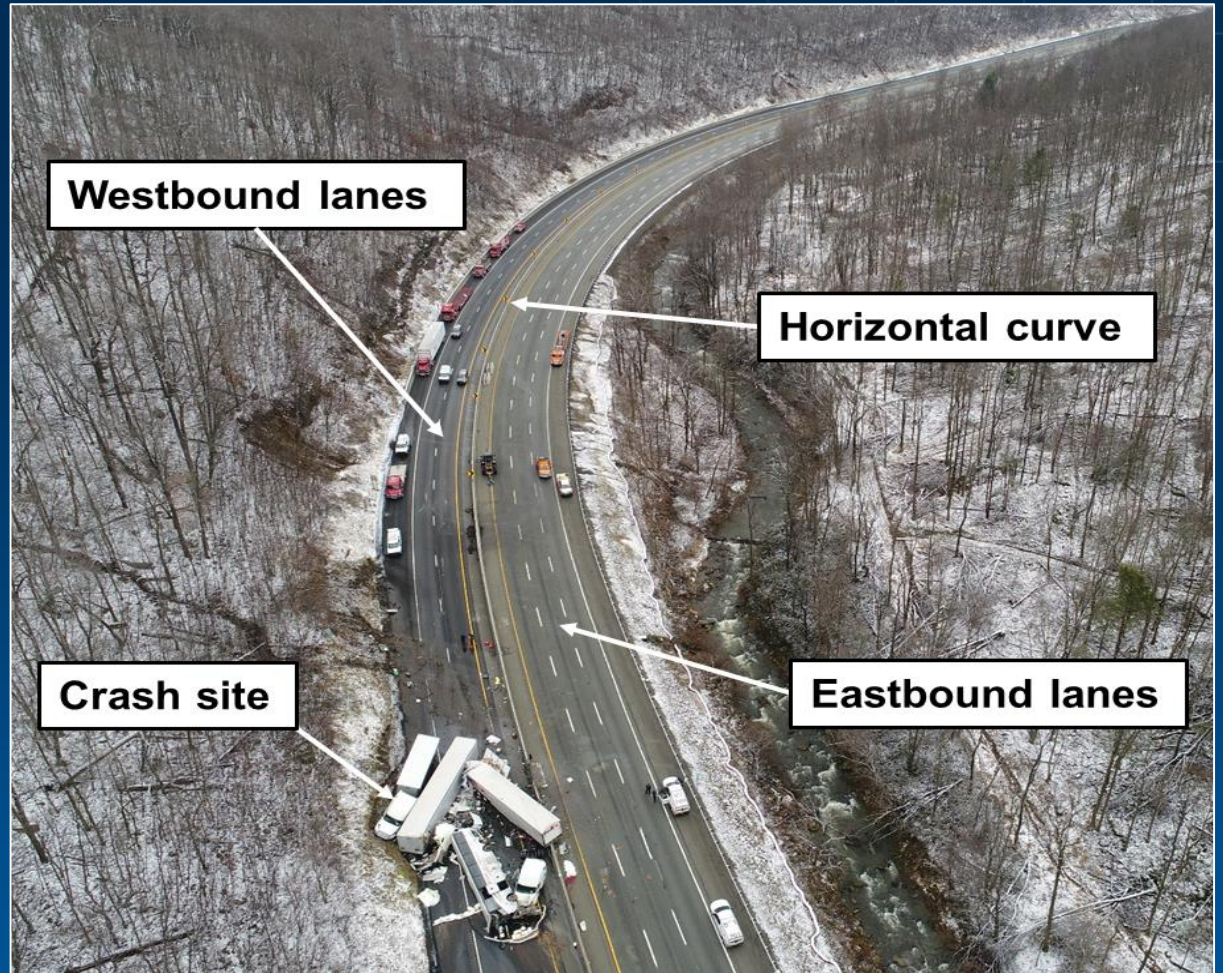
Highway Characteristics

- Turnpike
 - Built in 1940
 - Numerous horizontal curves
 - Crash occurred in westbound lanes
- Horizontal curve
 - Downgrade slope of 3 percent
- Grooved rumble strips
- Resurfaced in September 2019

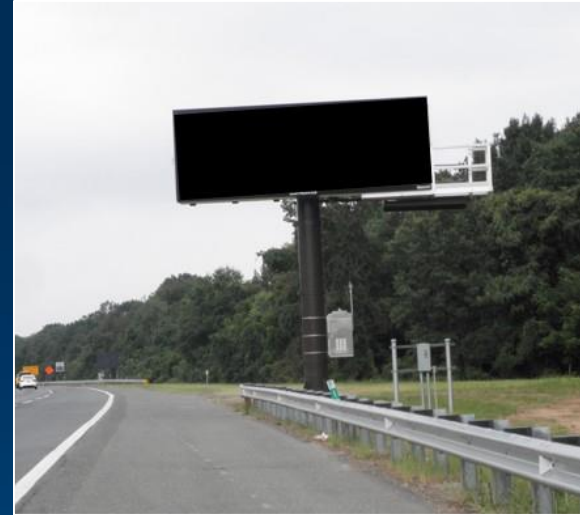
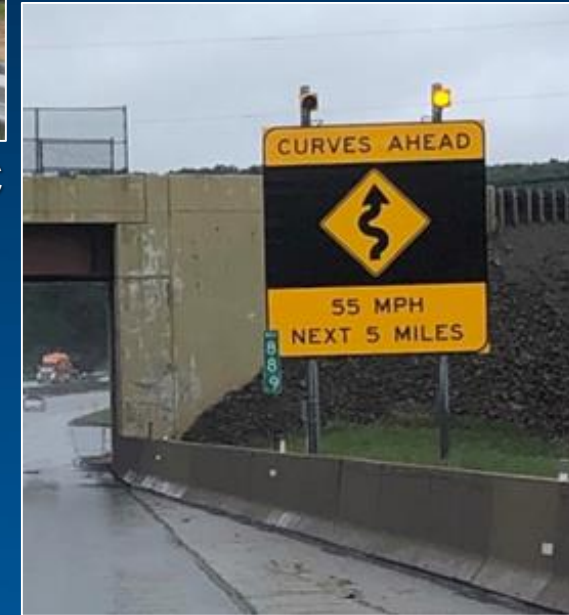
Signage

- 38 signs installed along westbound lanes
- 5 dynamic message signs
- “Curves ahead” advisory speed sign with flashing beacons
 - Warn motorists to reduce speed to 55 mph, particularly at night
- Connected vehicle technology
 - Harrisburg Connected Project

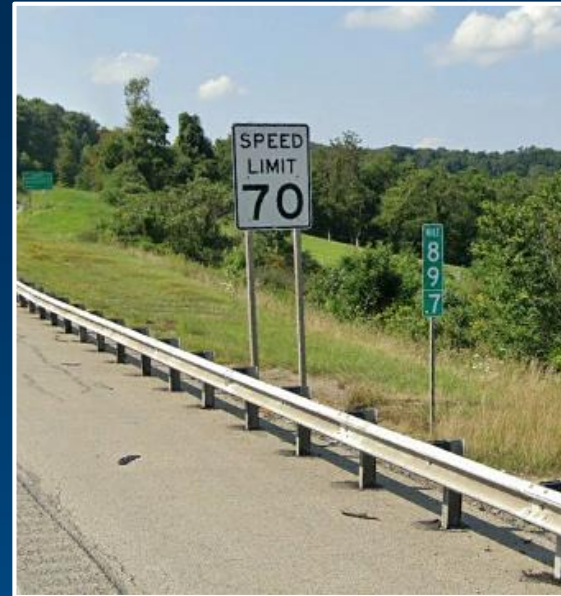
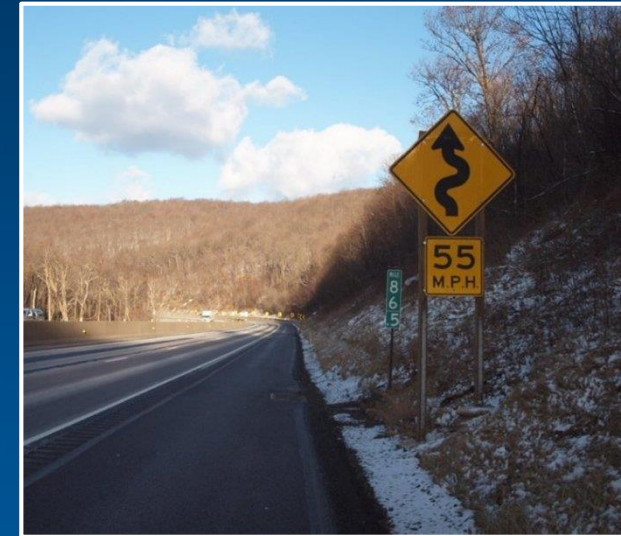
Speed Limits

- Regulatory 70 mph speed limit
 - Maximum speed on highway section, established by law, and is enforceable
 - 1,054 miles of straight sections
- Advisory 55 mph speed sign
 - Recommended safe speed for all vehicles, not enforceable
 - 150 horizontal curves (51 miles) for advisory speeds of 55, 60, 65 mph
